**Electromagnetic Effects Harmonization
Working Group (EEHWG)—Lightning
Task Group: Report on Aircraft
Lightning Strike Data**

July 2002

DOT/FAA/AR-TN02/66

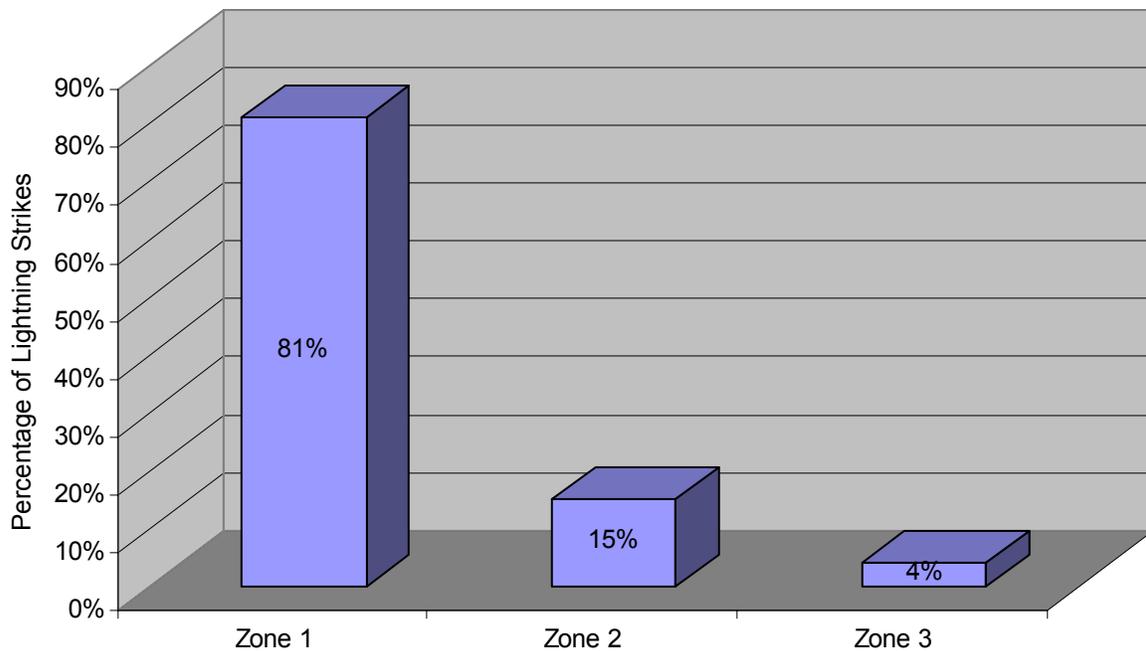
The following assumptions should be applied to figures A-1 through A-9.

FIGURE A-1. SUMMARY OF ALL DATA – REPRESENTATION BASED ON DATA SUBSETS MUTUALLY INCLUSIVE

At face value the plots imply percentage of strikes noted in zones defined by AC 20-53A. What constitutes a strike? An arc attachment? For a single incident, on this definition, there should be a single strike in Zone 1A and one in Zone 1B, i.e., two in Zone 1 in total
